**INVESTIGATING THE LIMITATIONS OF THE CURRENT  
UK WATER PIPE MATERIAL RISK ASSESSMENT GUIDANCE AND  
PROCEDURES**

**Dissertation presented for the  
Degree of MRes in Contaminated Land Management**

**School of Geography  
University of Nottingham**

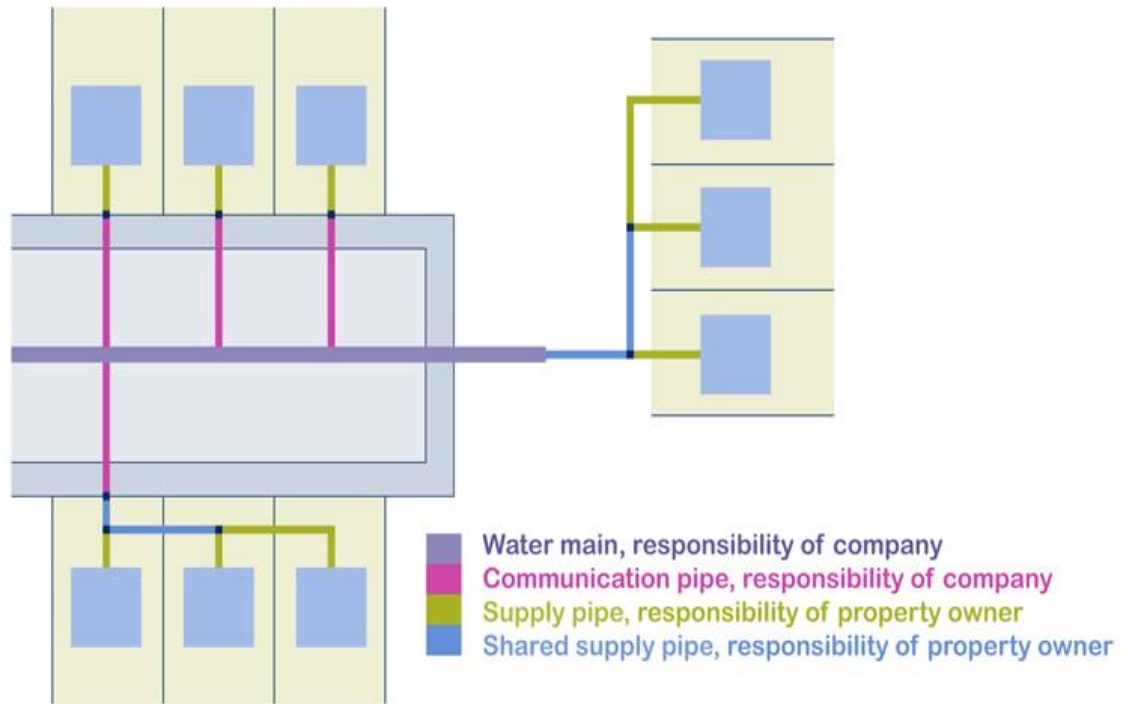
**Figure 2 Responsibility for water pipes (Source: <http://www.ofwat.gov.uk/consumerissues/rightsresponsibilities/supplypipes/> (Accessed July 2014))**

Water companies are responsible for the repair and maintenance of the water mains and communication pipes. Communication pipes carry water between the water mains and the boundary of the domestic property.

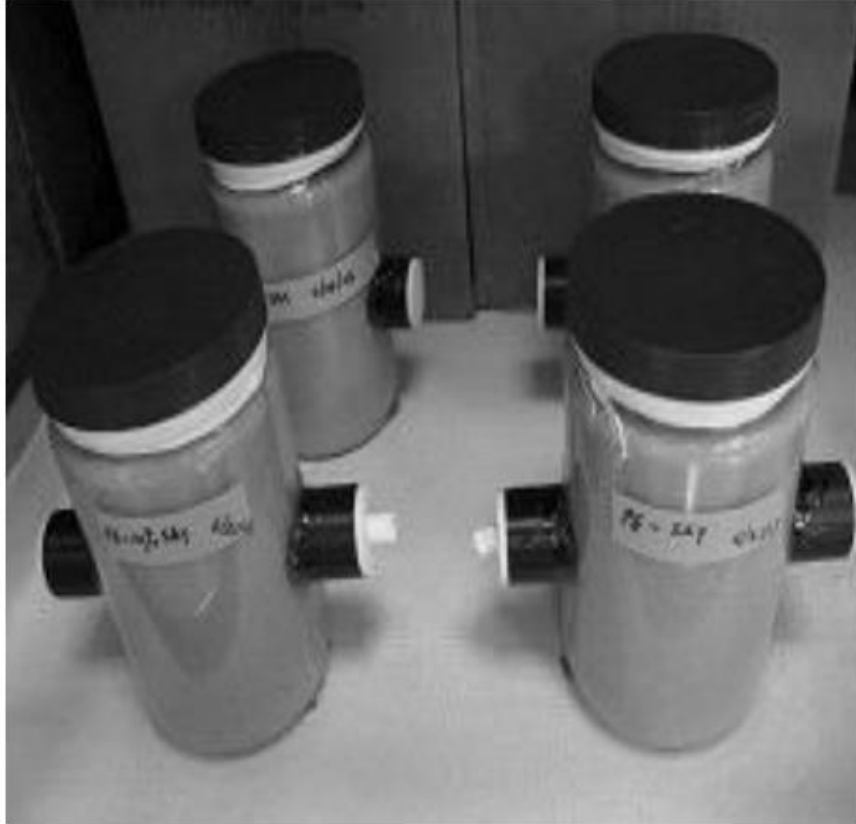
**Figure 3 Pipe-bottle apparatus (Ong *et al.* 2008, Figure 3.1)**

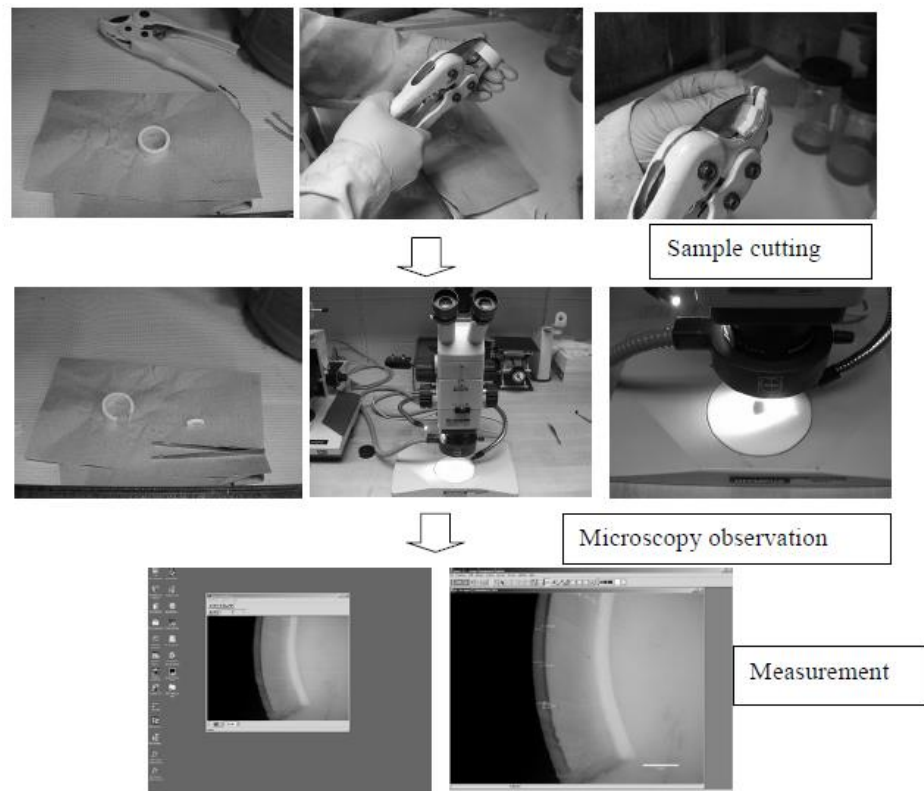
**Figure 4 Microscopic visualization procedure 'moving front test' (Ong et al.2008, Figure 5.10)**

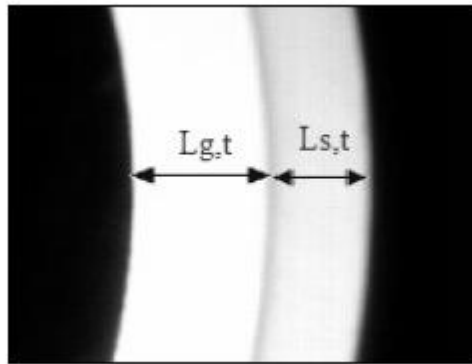
**Figure 5 Moving front and definition of  $L_{g,t}$  (thickness of the remaining glassy core at time) &  $L_{s,t}$  (thickness of the swollen layer at time) (Ong et al.2008, Figure 5.9)**

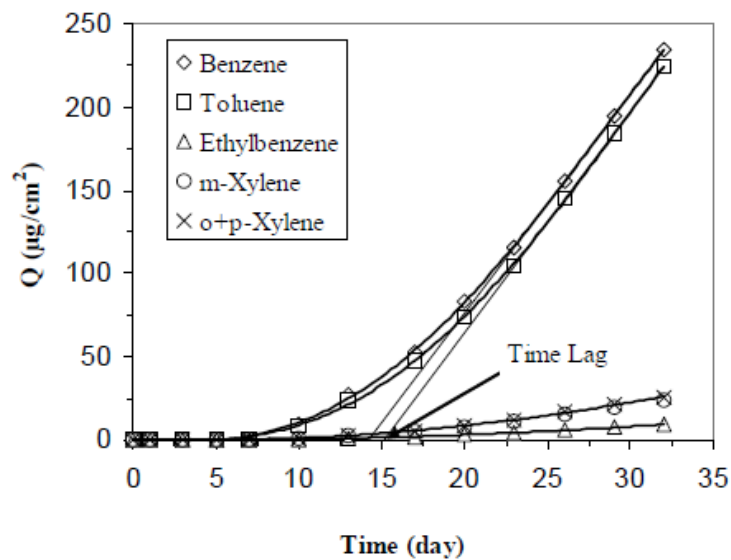
**Figure 3.2 Cumulative mass permeated per unit area for BTEX compounds in PE pipe exposed to premium gasoline (Benzene, 19.8 g/L; toluene, 75.9 g/L; ethylbenzene, 14.7 g/L; m-xylene, 33.7 g/L; o+p xylene, 32.5 g/L)**

**Figure 8 Cumulative mass permeated per unit area for BTEX in PE pipe exposed to pure gasoline (Ong et al. 2008, Figure 3.2)**

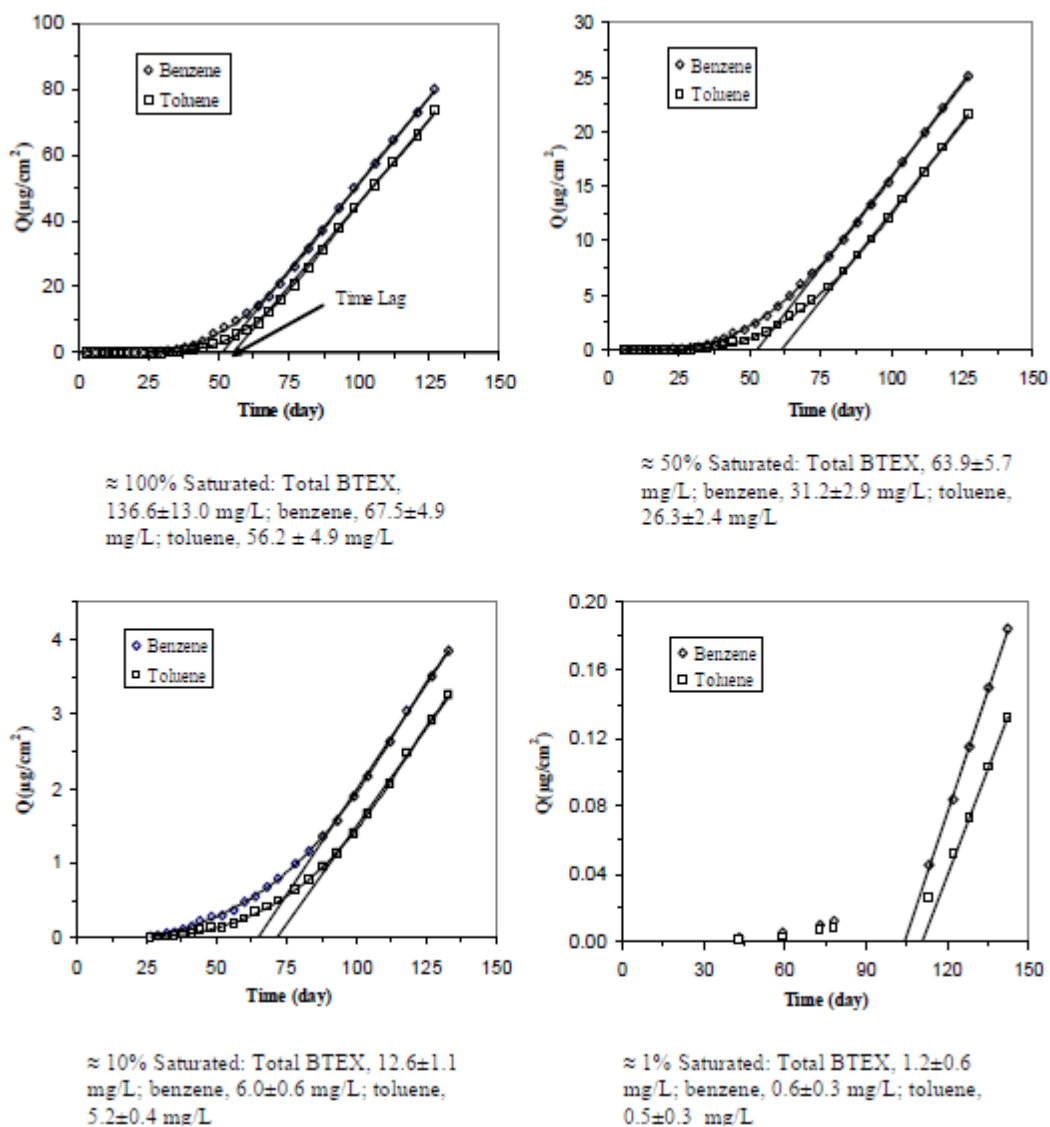
**Figure 9 Cumulative mass permeated per unit area for benzene and toluene in PE pipe exposed to gasoline-contaminated water (Ong et al. 2008, Figure 3.2)**

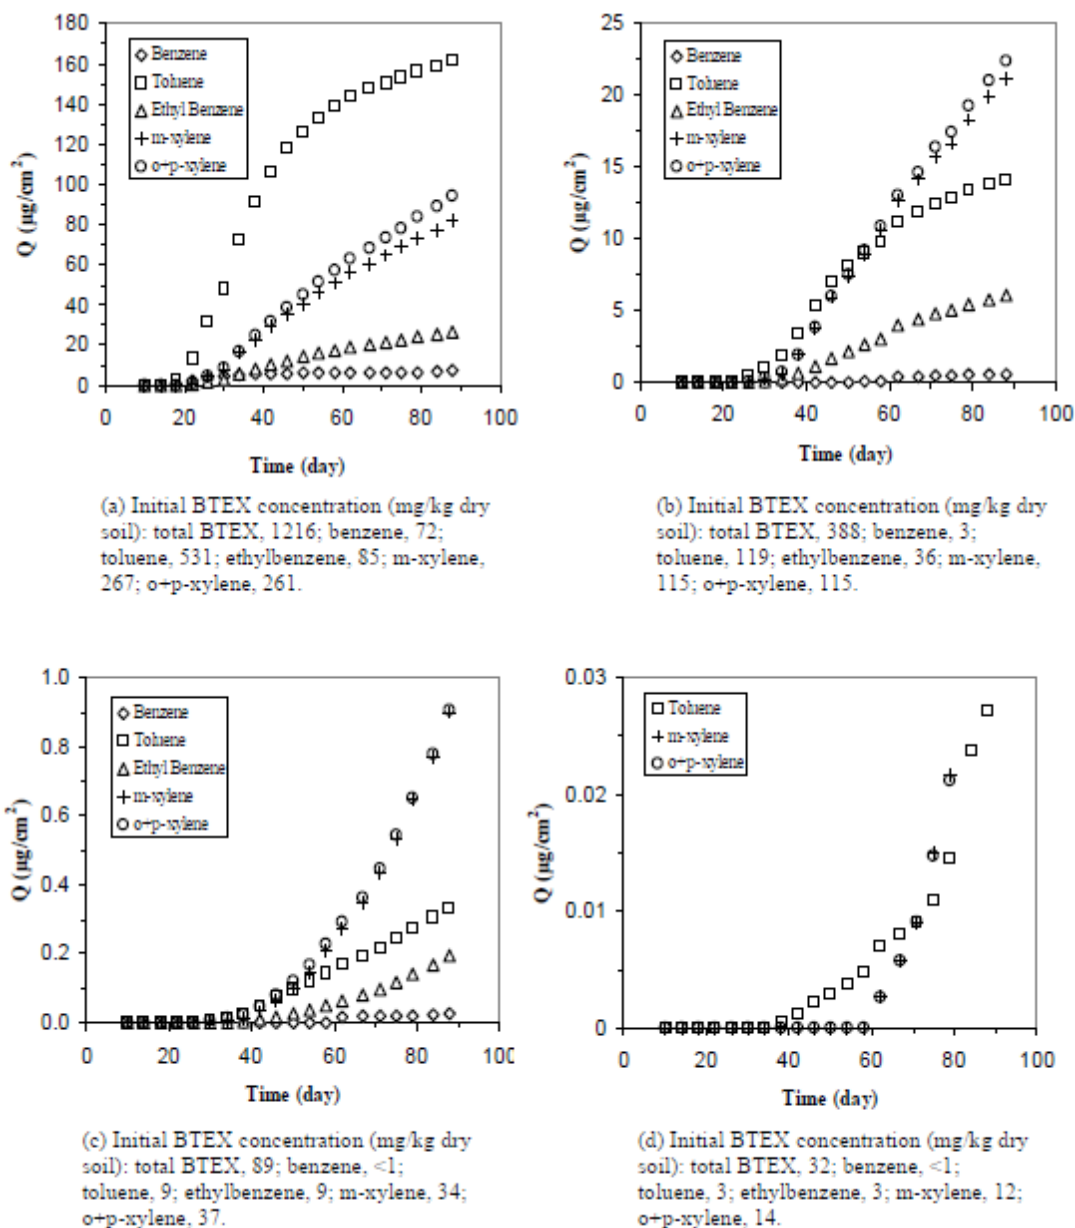
**Figure 10 Cumulative mass permeated per unit area for BTEX in PE pipe exposed to gasoline-contaminated soil (Ong et al. 2008, Figure 3.8)**

- Toluene and xylene were the major contributors were pipes were exposed to contaminated-soils in unsaturated conditions (Figure 10). Whilst benzene and ethylbenzene were insignificant. A possible explanation for low permeation of benzene is due to its high soil sorption affinity. Based on this plastic pipes buried in water saturated zone would be more susceptible to benzene permeation than in the vadose(unsaturated) zone.

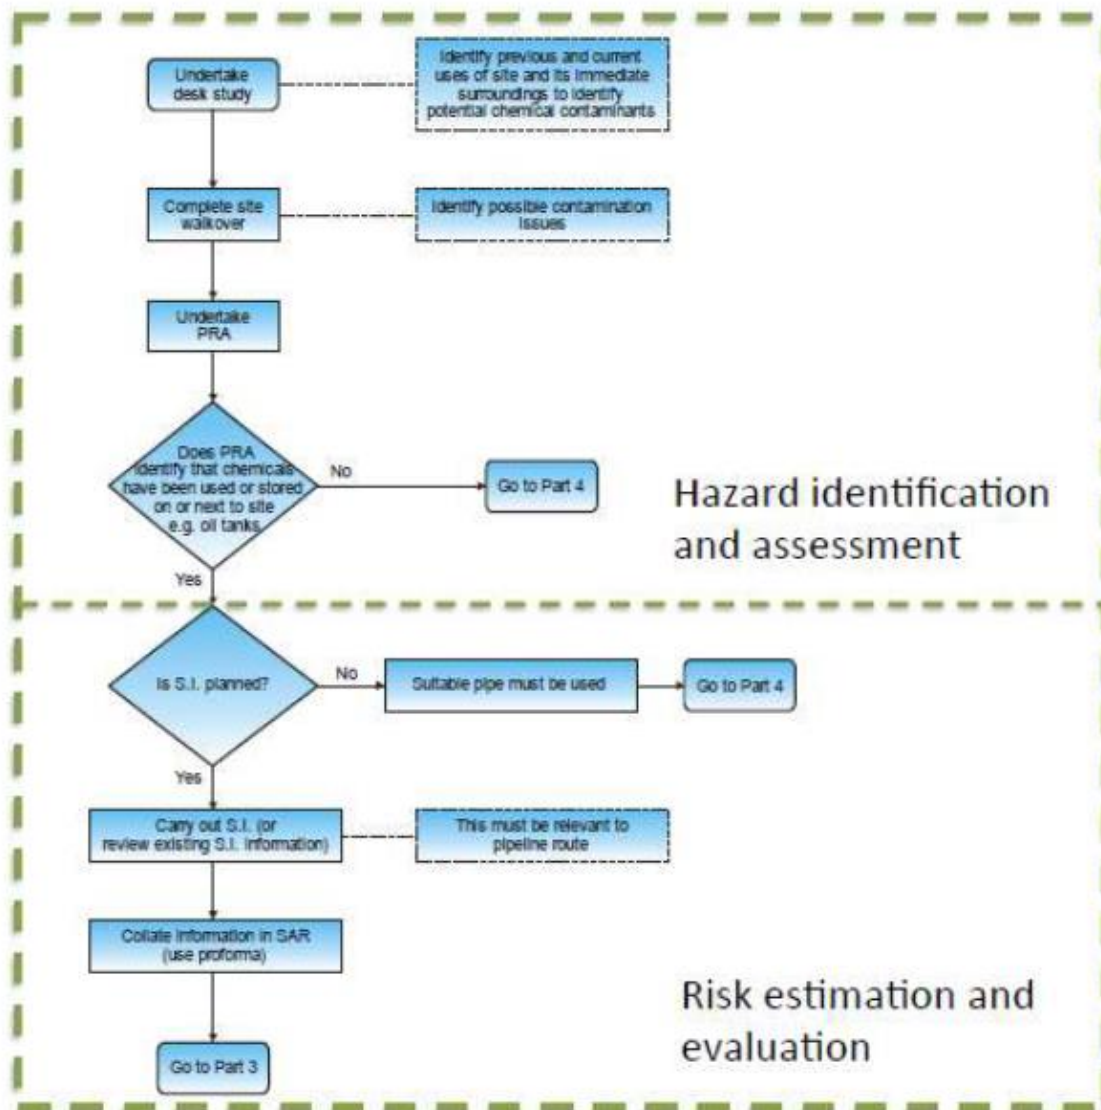
**Figure 12 Annotated extract from the UKWIR2010: Site Assessment Process and Requirements Figure (UKWIR 2010 – Figure 2.1) (Blackmore *et al.* 2010)**

UKWIR2010 presents a site assessment and requirements flow chart (Figure 2.1), an extract of which is presented as Figure 12. Figure 12 has been annotated to identify activities associated with hazard identification and assessment (phase 1) and risk estimation and evaluation (phase 2) RA phases.

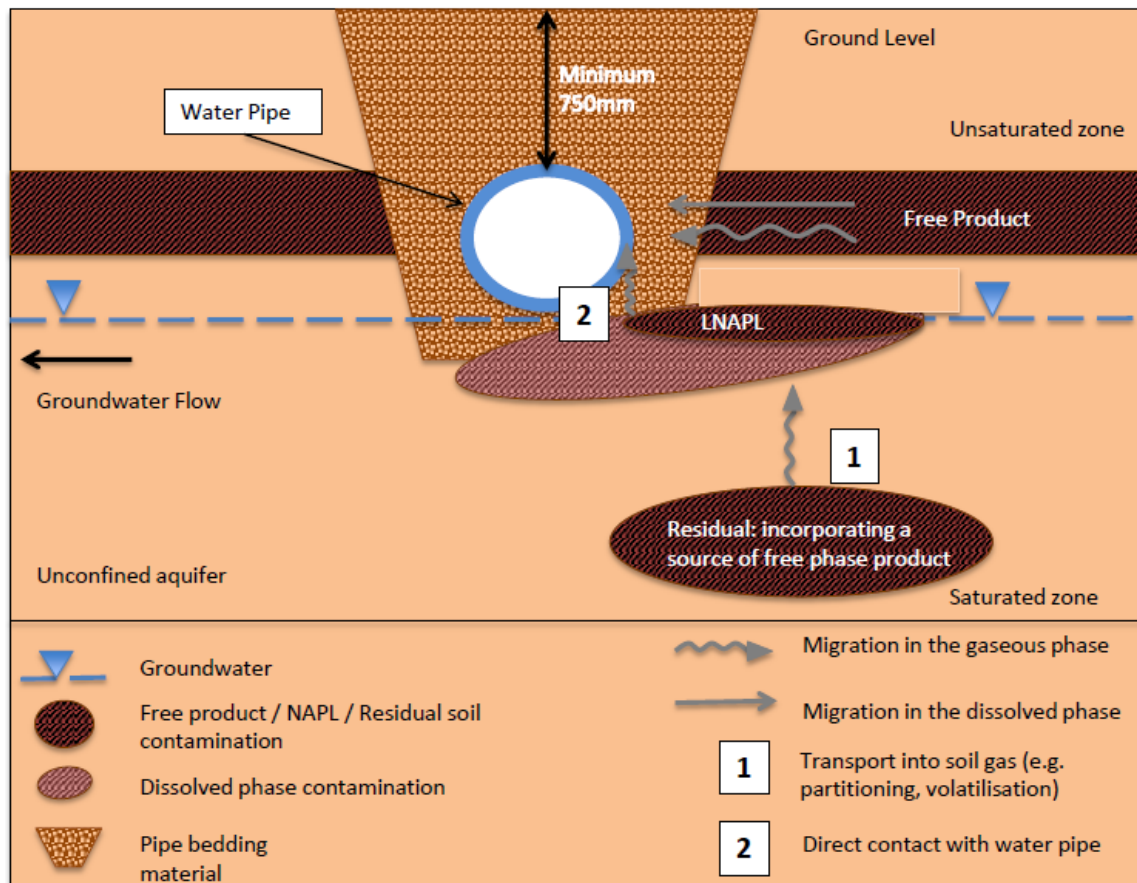
**Figure 13 CSM to illustrate potential contaminant linkages relevant to plastic water pipe receptor with a high groundwater level**

**Error! Reference source not found.** Figure 13 and Figure 14 present generic CSM's that illustrate potential pollutant linkages relevant to plastic pipe materials.

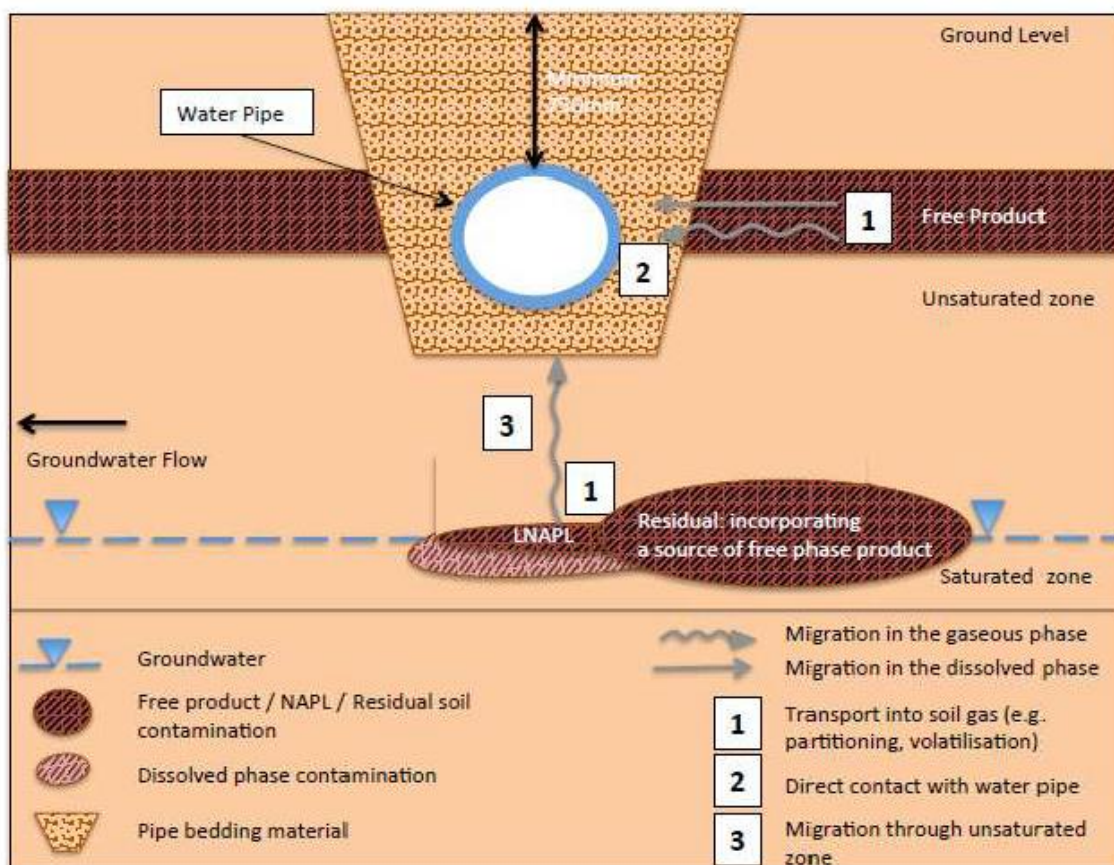
**Figure 14 CSM to illustrate potential contaminant linkages relevant to plastic water pipe receptor with a low groundwater level**

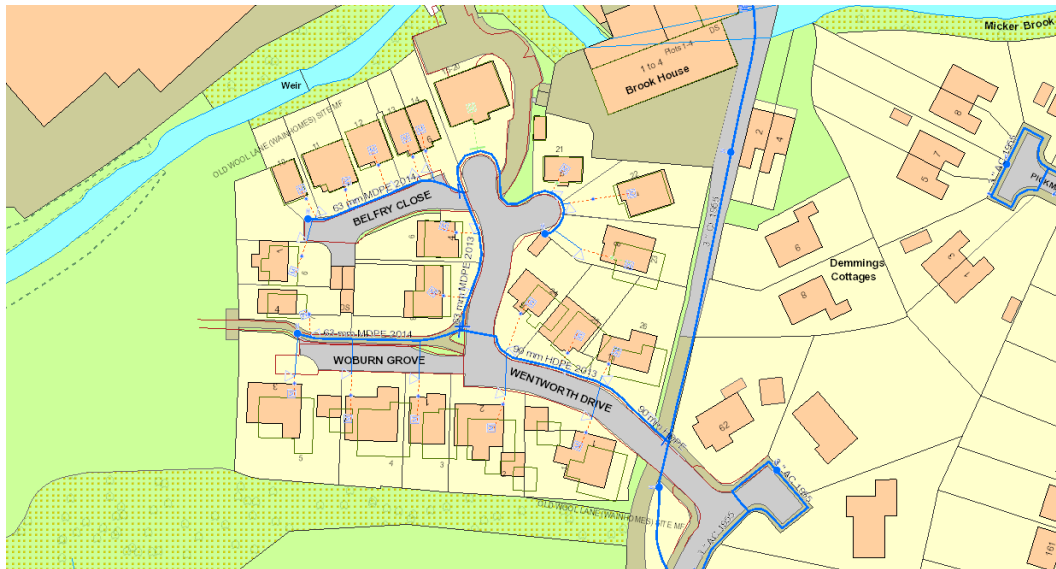
**Figure 39 GIS utility mapping - Old Wool Road - Clean water asset map information (Key: Green assets indicate 'proposed' BP installations across the development [Accessed November 2015])**

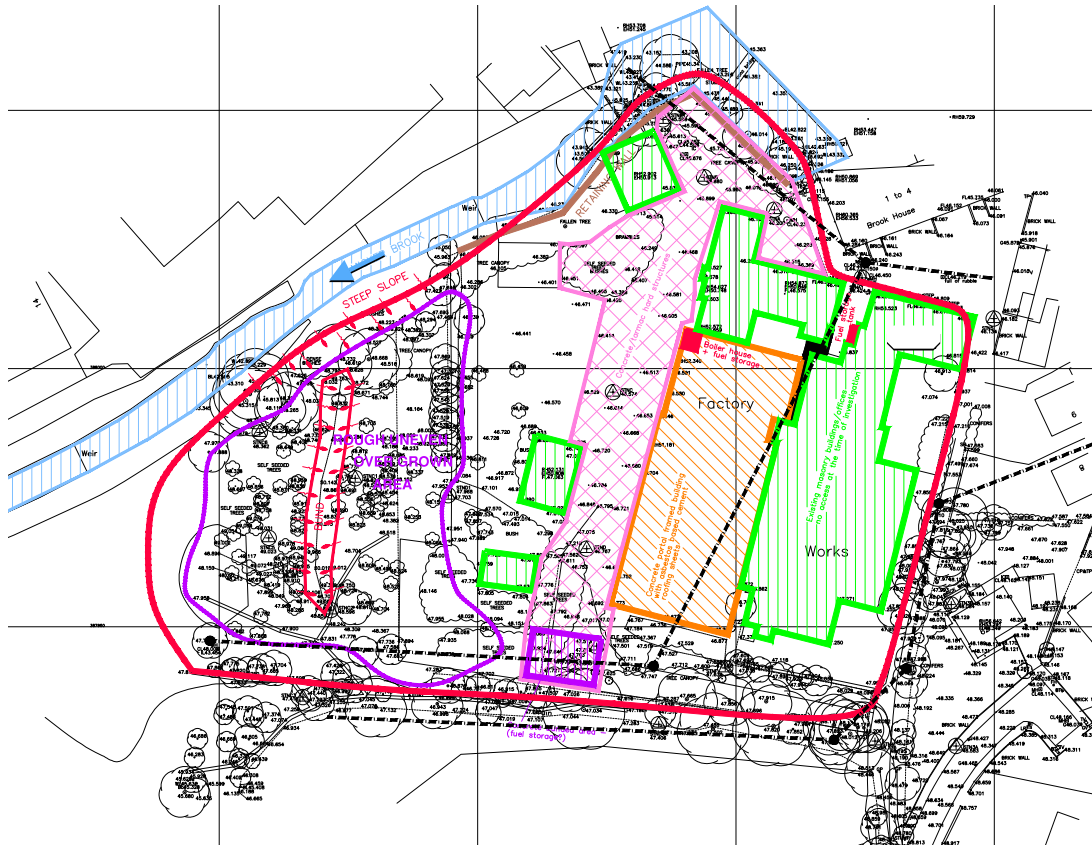
**Figure 41 Site Layout and potential areas of concern (Appendix G – Walkover Survey Plan (GI, 2012))**

A site walkover plan was provided, which identifies several potential fuel storage areas. **Figure 41**

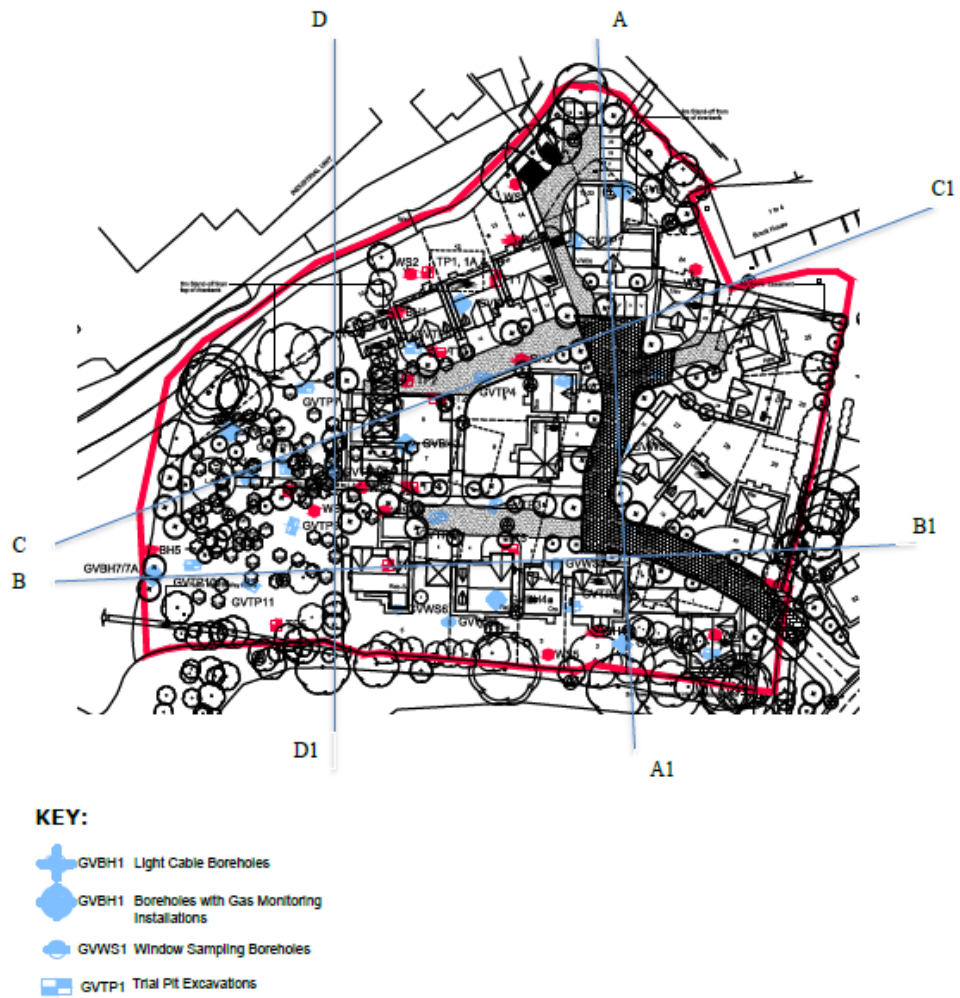
**Figure 43 Exploratory hole location plan, section lines and proposed development layout (base drawing is taken from Appendix F – Ground Investigation Location Plan and proposed site layout (GI, 2012))**

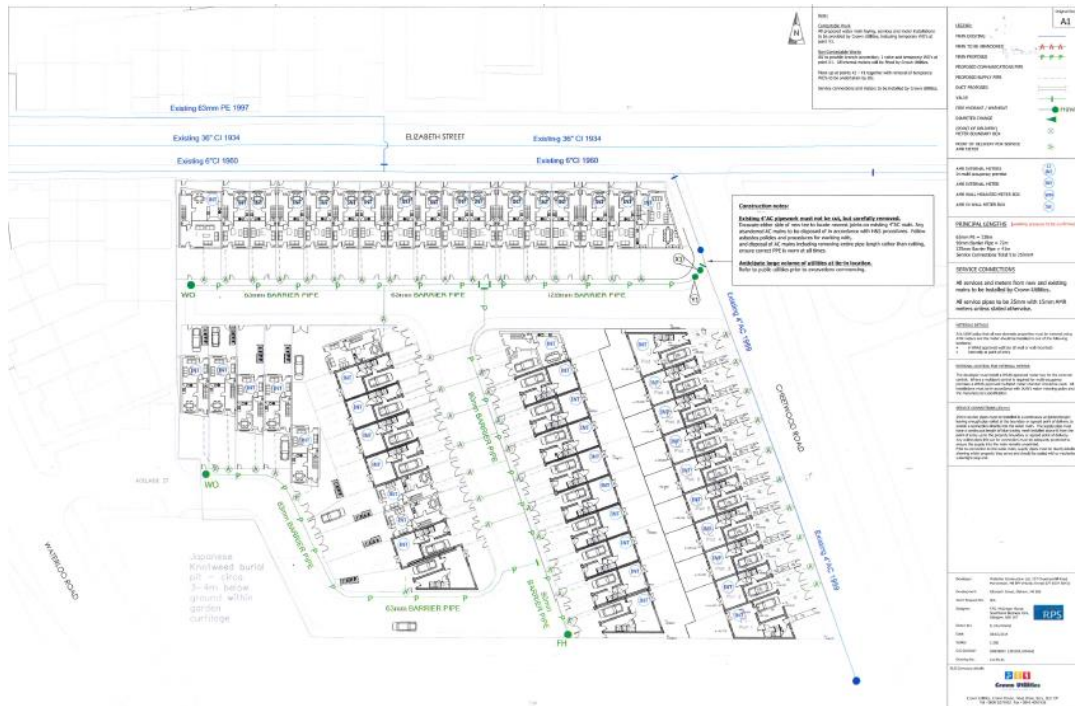
**Figure 48 Developer/SLO Water Pipe Design Proposal (drawing Ref - CU-ES-01)**

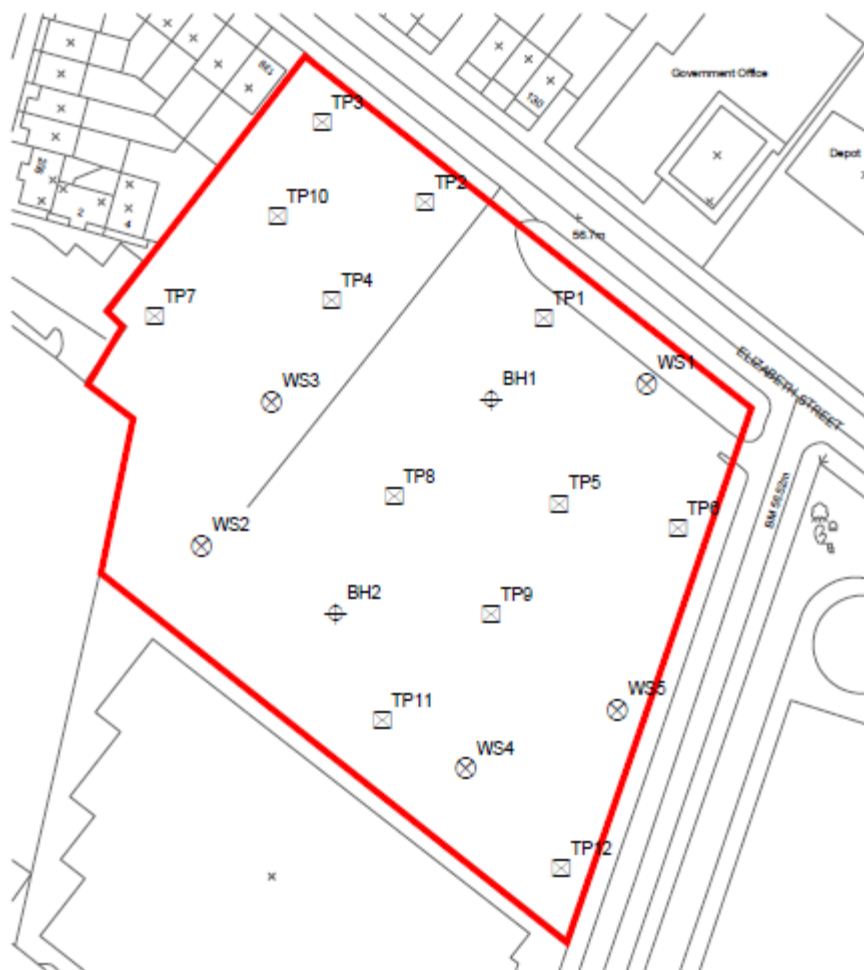
**Figure 50 Exploratory hole location plan (Combined Report 2007)**

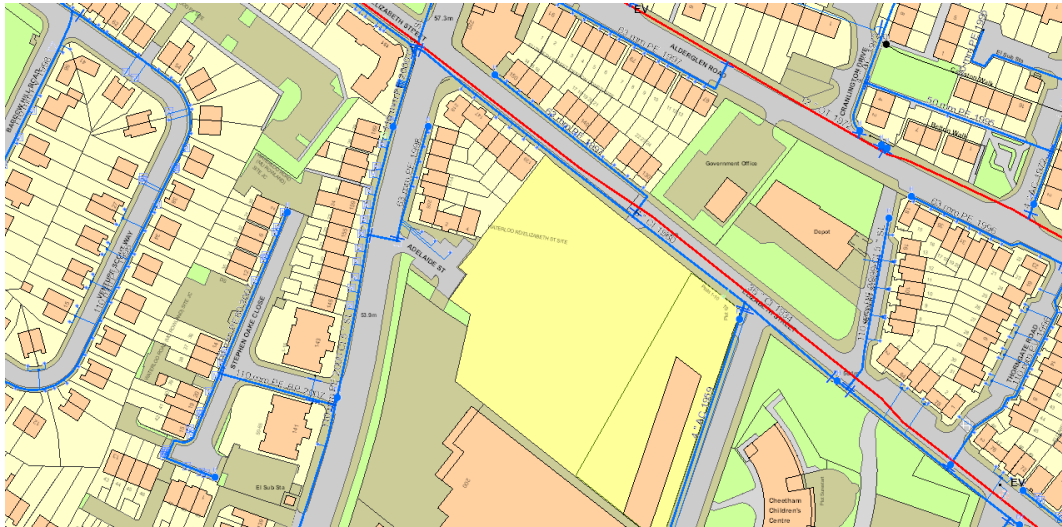
**Figure 55 GIS mapping - Elizabeth Street site – Clean water asset map information (Key: yellow indicates no clean water asset records)**

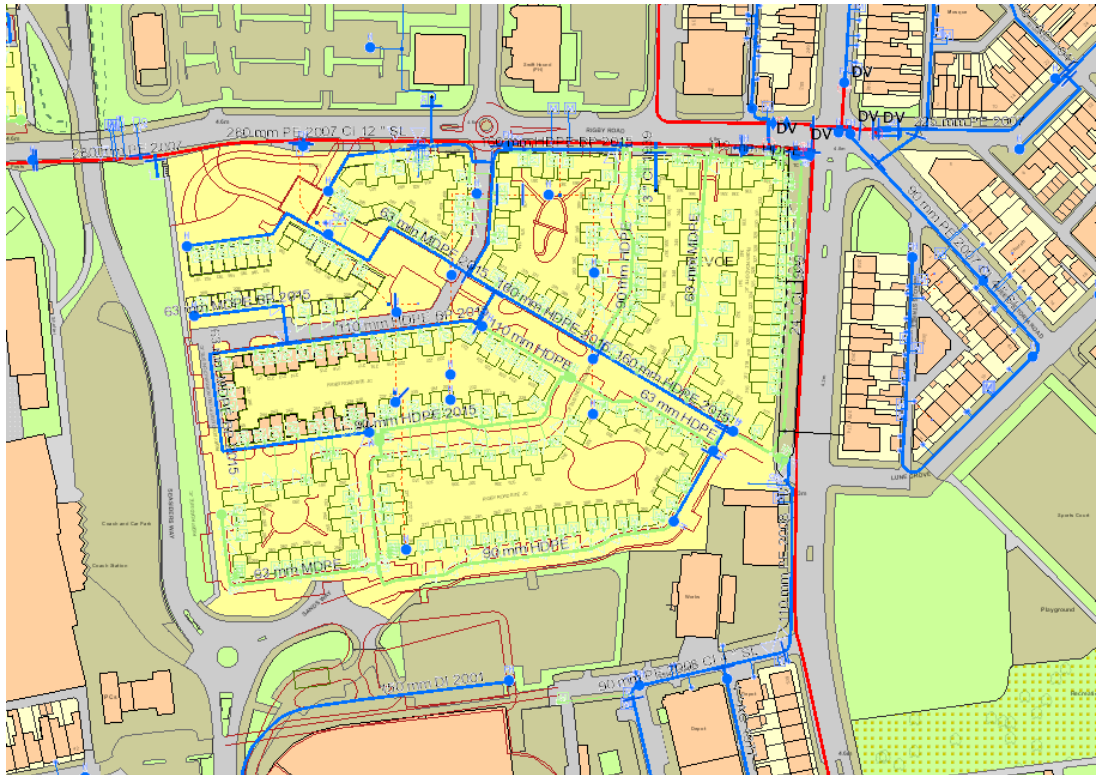
**Figure 57 GIS mapping – Rigby Road East – Clean water asset map information (Key: Blue assets are installed asset, green assets are proposed assets following WC consultation) [GIS accessed November 2015]**

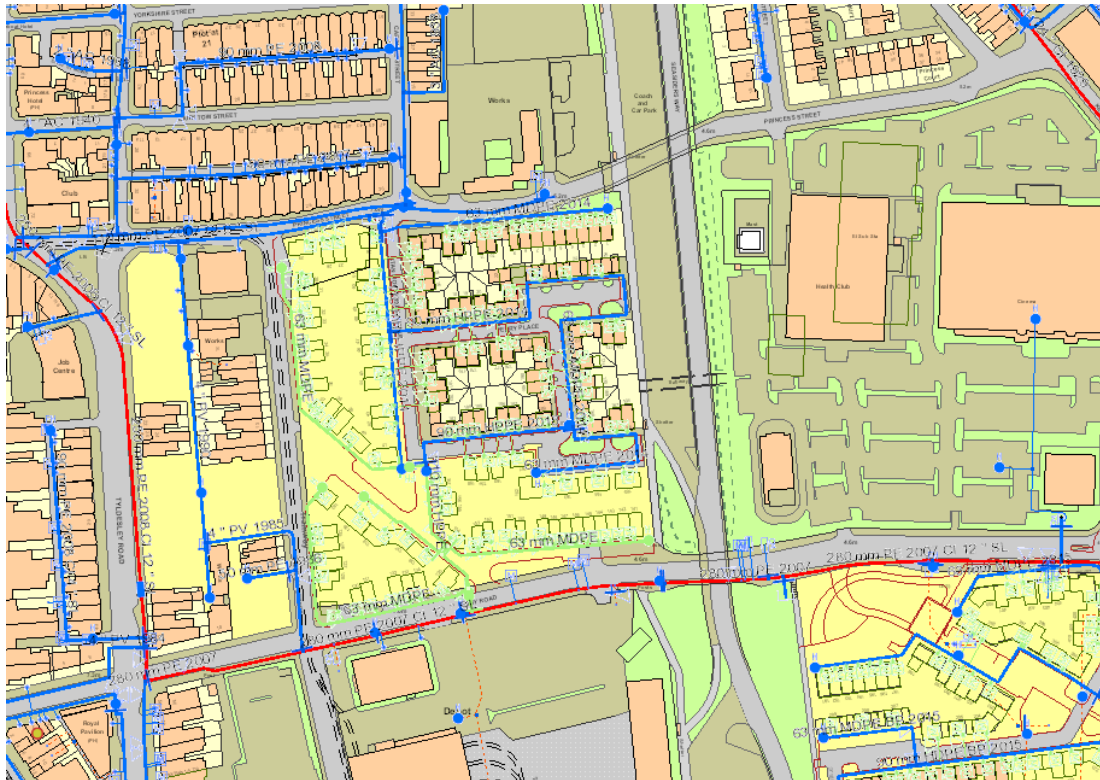
**Figure 58 GIS mapping – Rigby Road West – Clean water asset map information (Key: Blue assets are installed asset, green assets are proposed assets following WC consultation) [GIS accessed November 2015]**

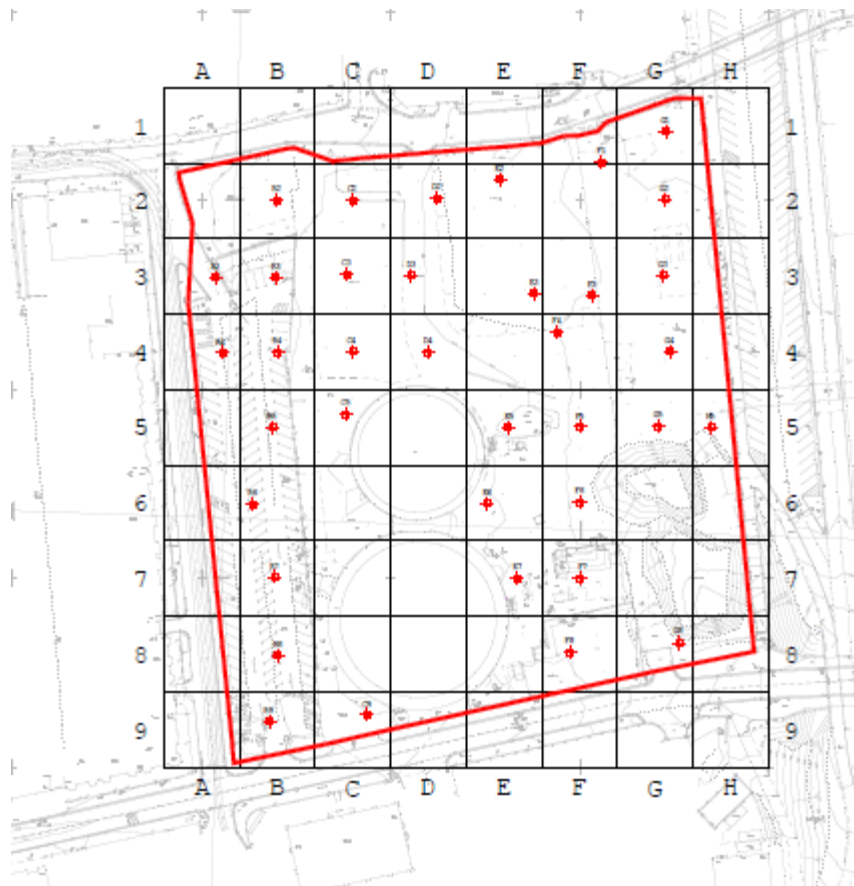
**Figure 60 Exploratory hole location plan - West Site (Factual Report 2013)**

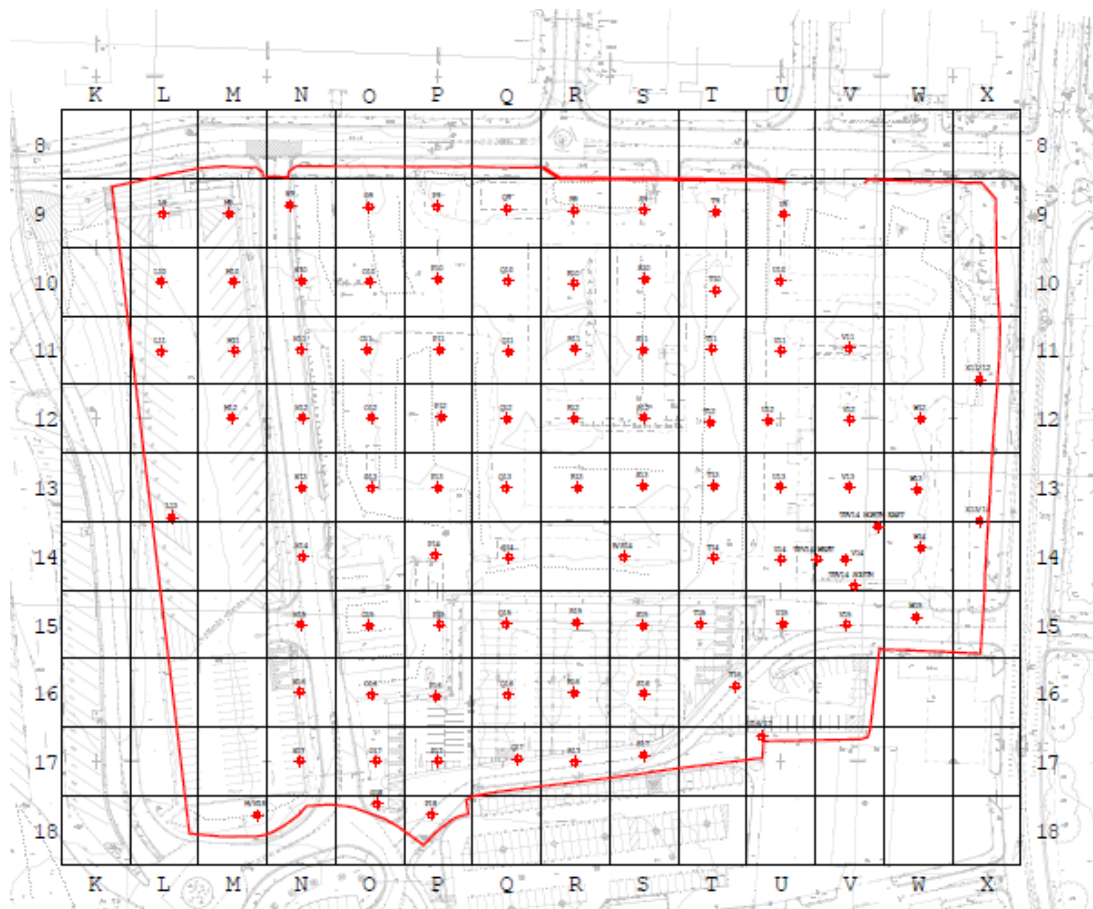
**Figure 61 Exploratory hole location plan - East Site (Factual Report 2013)**
